WASTE MANAGEMENT DIVISION

RCRA ENFORCEMENT OFFICE

Purpose:	RCRA Compliance Evaluation Inspection
Facility:	Boeing Commercial Airplane Group 3855 Lakewood Boulevard Long Beach, CA 90846
EPA ID Number:	CAD008378044
Date of Inspection:	August 20, 2003
EPA Representatives:	Clint Seiter Environmental Protection Specialist (415) 972-3298 Cameron McDonald Environmental Protection Specialist (415) 972-3308
Long Beach Dept. of Health & Human Services:	Cheryl Sandel Hazardous Material Specialist (562) 570-4127
Facility Representative:	David Ganoung Manager (562) 593-4285
Report Prepared By:	Clint Seiter
Report Date:	October 2, 2003

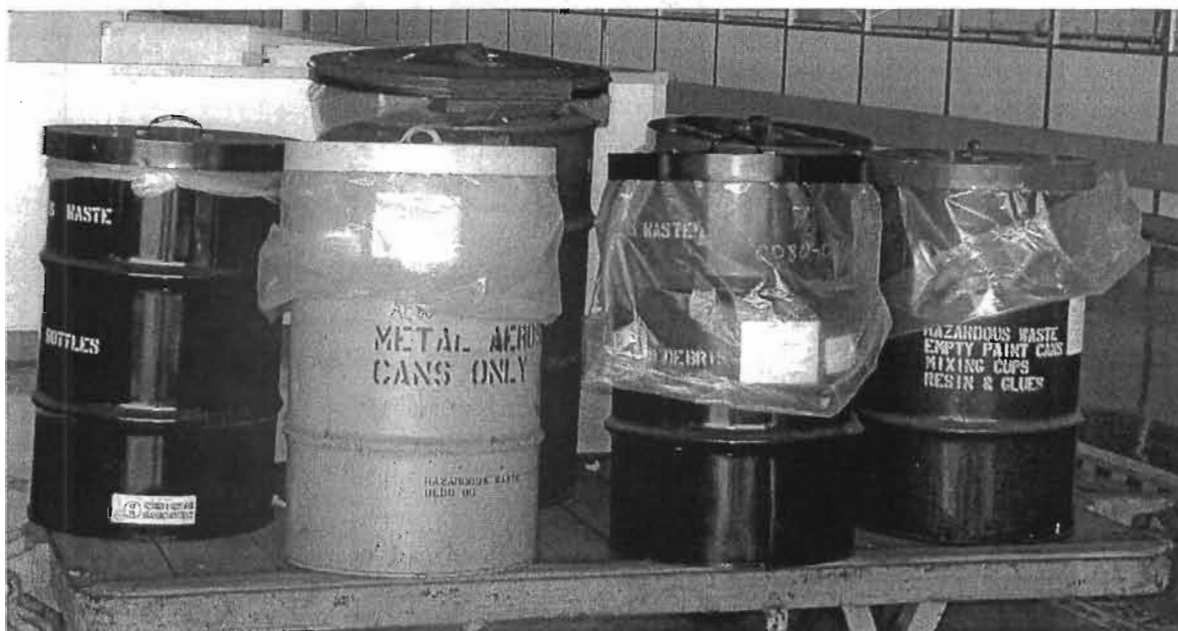
The assembly of the planes' components take place in this building. The fuselage of the plane moves down the length of the building by a chain-driven assembly line, where its component parts (including the wire harness) are attached and the lubricating fluids are added. There are numerous satellite accumulation areas throughout the building, identified by their location to the nearest building column (numbers: east-west, letters: north-south, e.g. 5B). Satellite accumulation area drums are color-coded to identify the type of waste that goes in them: yellow for aerosol cans, red for solvent-soaked rags, blue for paint cans/mixing cups/resins and adhesives, green for sealant tubes. Black drums signify either oil contaminated debris, spent batteries, or other miscellaneous waste (Attachment 1, Photo 1). Every satellite accumulation drum gets a unique identifying number that is tracked on a database maintained by the facility's administrative staff (Attachment 1, Photo 2). The drum code numbers identify the type of waste containerized, the location of the drum, the current year, and the specific drum. The inspectors selected two containers at random and had the facility representative look up their drum code numbers on the database. In both instances the database was able to accurately describe the drum and its contents. Satellite accumulation areas are inspected weekly.

Photo 1: Typical satellite accumulation area in Building 80

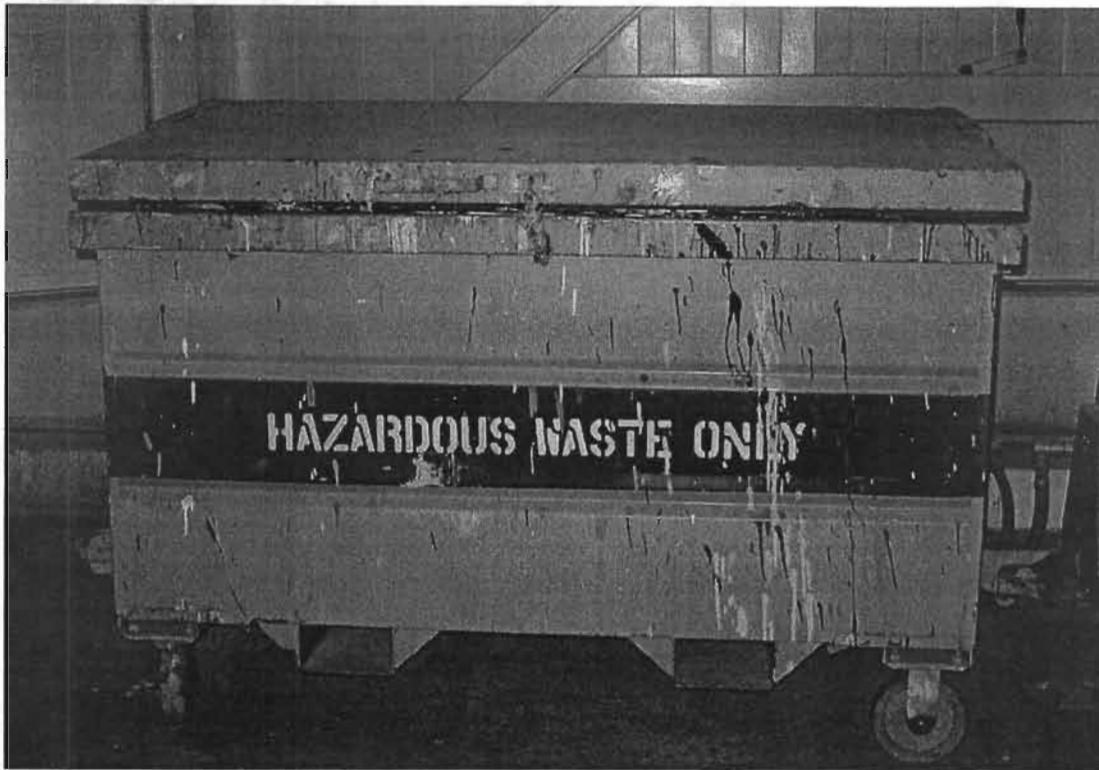
Extensive painting operations are conducted within this building. At the time of the inspection there was one 3-cubic-yard, gasketed bin in which discarded paint cans and other paint-related debris were stored (Attachment 1, Photo 3). No violations were noted.

Photo 3: Gasketed bin for paint waste in Building 87

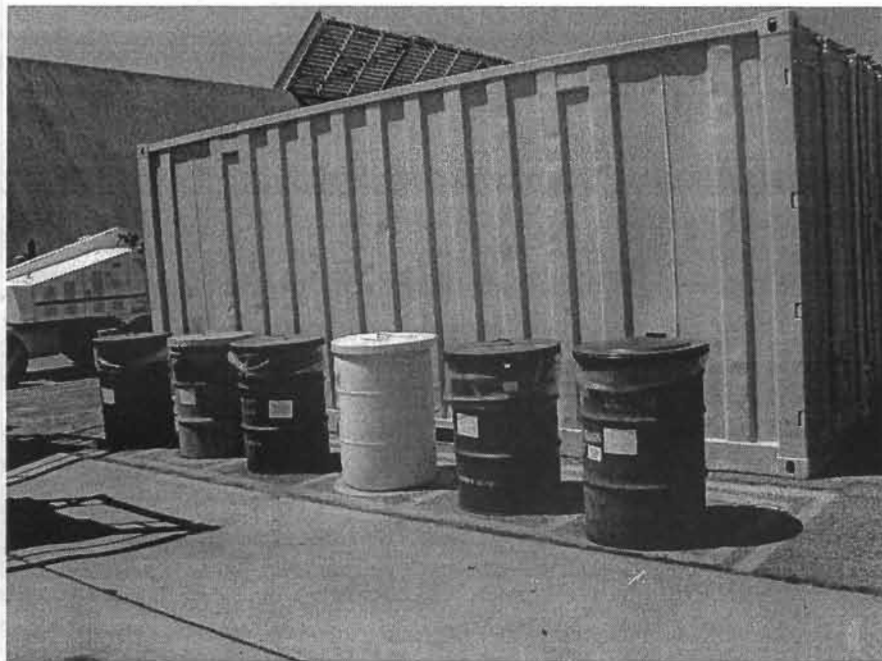
Newly assembled airplanes undergo various tests here (flaps, hydraulic systems, vertical stabilizers, radar, electrical systems, etc.). There are three positions on the ramp for testing, and each position has its own satellite accumulation area (Attachment 1, Photo 4). No hazardous waste violations were noted.

Photo 4: Ramp satellite accumulation area

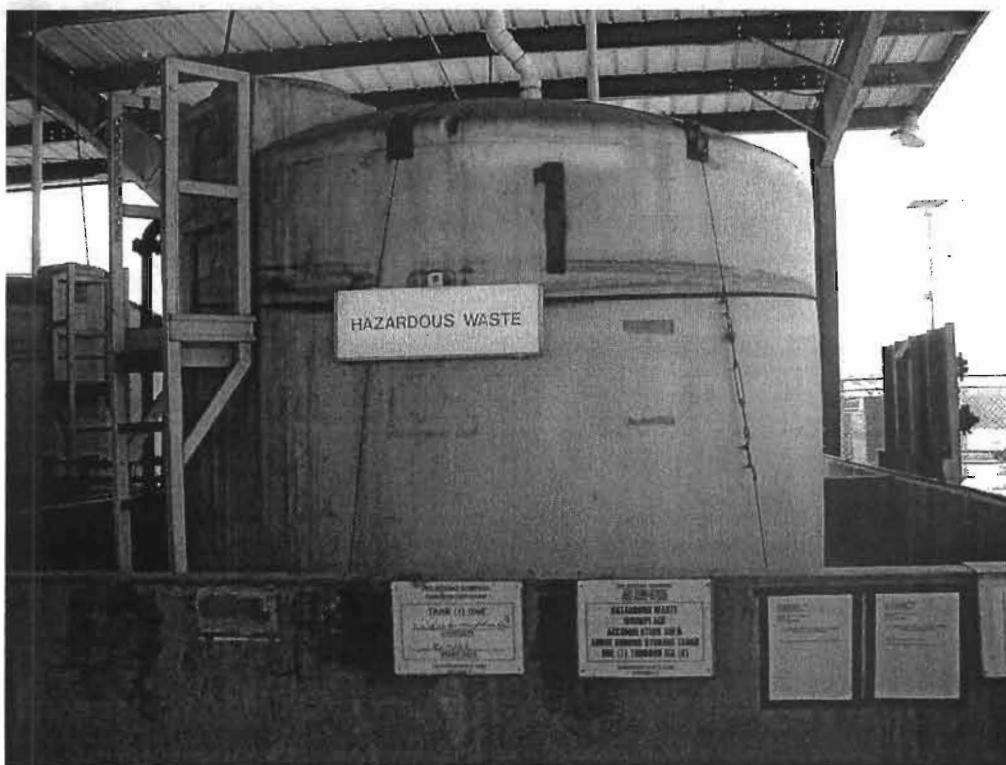
Hazardous waste generated from the ramp and from TCE-contaminated monitoring wells is stored in this fenced yard. The waste is stored in drums, and, in the case of the TCE-contaminated water, also in six 4500-gallon tanks (Attachment 1, Photos 5 and 6). All containers and tanks were in good condition, closed, and properly labeled. No violations were noted at the time of the inspection.

Photo 5: 4500 gallon tank for TCE-contaminated water

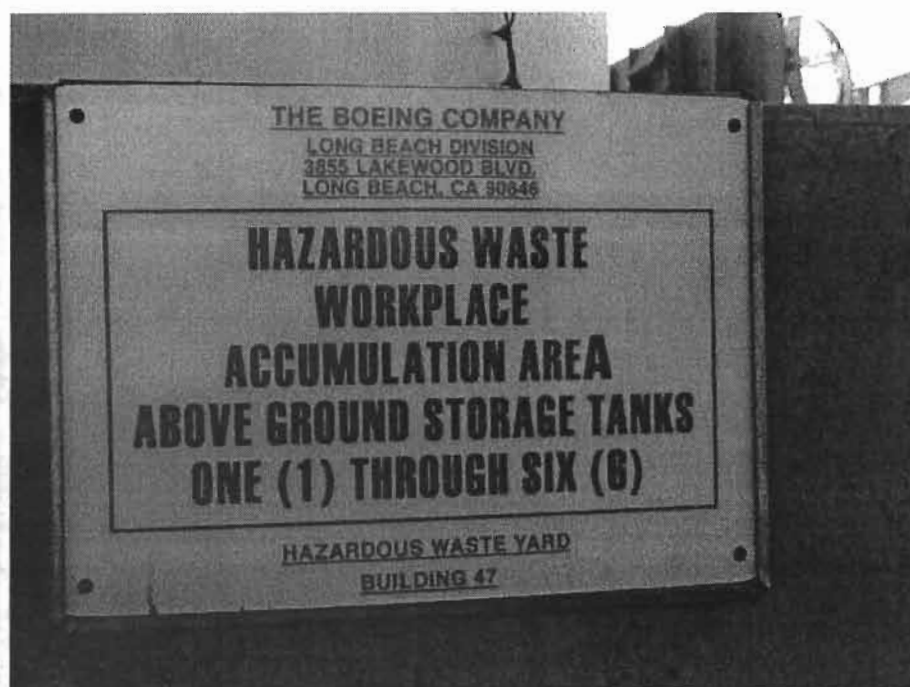
Photo 6: Wastewater tank label
